IN-1185
October 1968

CORROSION EXPERIENCE WITH TYPE 316 STAINLESS STEEL
IN SODIUM-POTASSIUM EUTECTIC ALLOY AT 1400°F

IDAHO NUCLEAR CORPORATION
NATIONAL REACTOR TESTING STATION
IDAHO FALLS, IDAHO

T. L. Hoffman

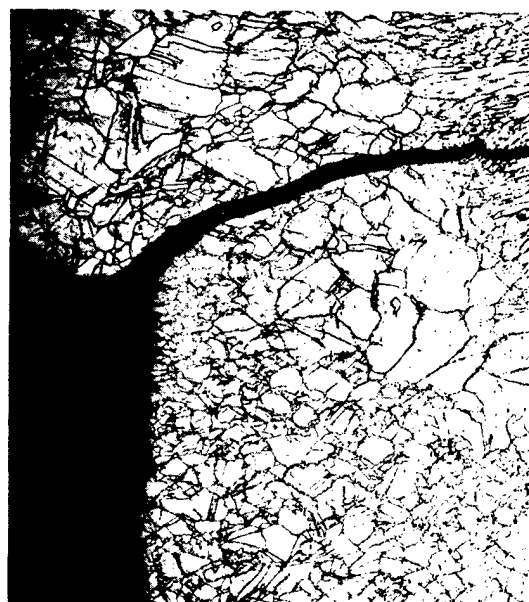
Figure 10 NaK expansion tank weld failure after 3,240 hours at 1100-1400°F service.

During the post-failure examinations of two pipe tee connectors, cracks were observed in welds; in addition, adjacent piping which was exposed for a total of 17,024 hours was cracked. Cracks were propagated both transgranularly and intergranularly, as shown in Figure 10. Notches which are sites for local stress raisers were found in each of these weld structures.

A microscopic examination of cross sections of the pipe-weld-pipe joint revealed only one crack in the weld and none in the piping. The crack was propagated both through the grains as a transgranular fracture and between the grains as an intergranular fracture, as shown in Figure 10. No plastic deformation of the grains of the weld occurred. No sigma phase or carbide precipitation at the grain boundaries of either the wrought piping or the case weld deposit was found. Electron microscope fractographs of this weld are typified by classic striations or crack arrest lines shown in Figure 12. By comparing this fractograph against published⁽¹⁵⁾ standards, the fatigue failure appeared to be caused by multi-cycle, low stress forces. Evidence of "dimples", typical of ductile fractures, were absent.

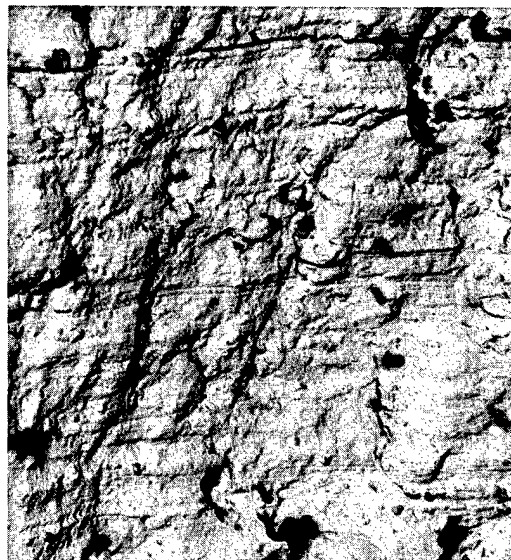
2.2 Connector Failure After 17,024 Hours Total Service

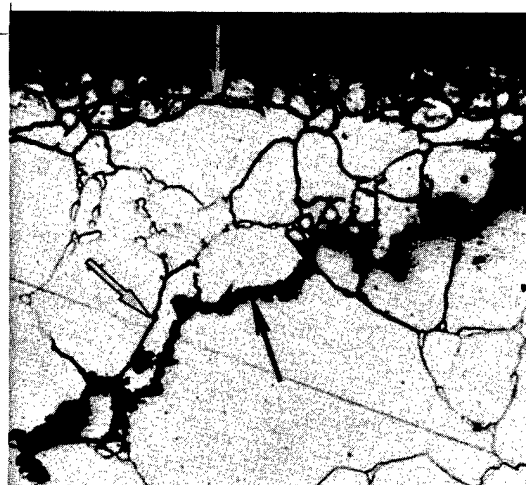
Figure 16 Crack on inside of pipe tee connector after 15,800 hours of service at about 1100-1400°F. Fine black lines indicated by white arrows are grain boundaries outlined by etching. Black arrow shows the crack.

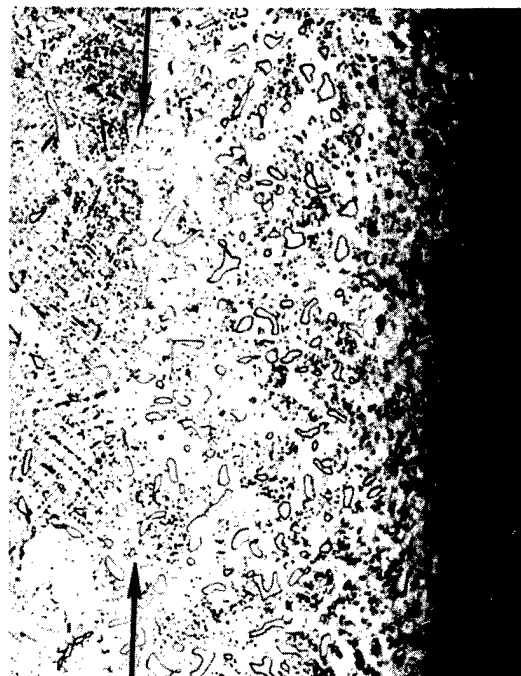
By repolishing the samples once more and re-etching with Vilella etchant, sigma phase was tentatively identified as being the large microconstituents shown in Figures 19 and 20. These particles were stained various opalescent colors by Murakami's etchant; thus, further confirming the presence of sigma phase. The fine precipitates evident in Figure 18, are most likely chromium carbides since sigma phase forms

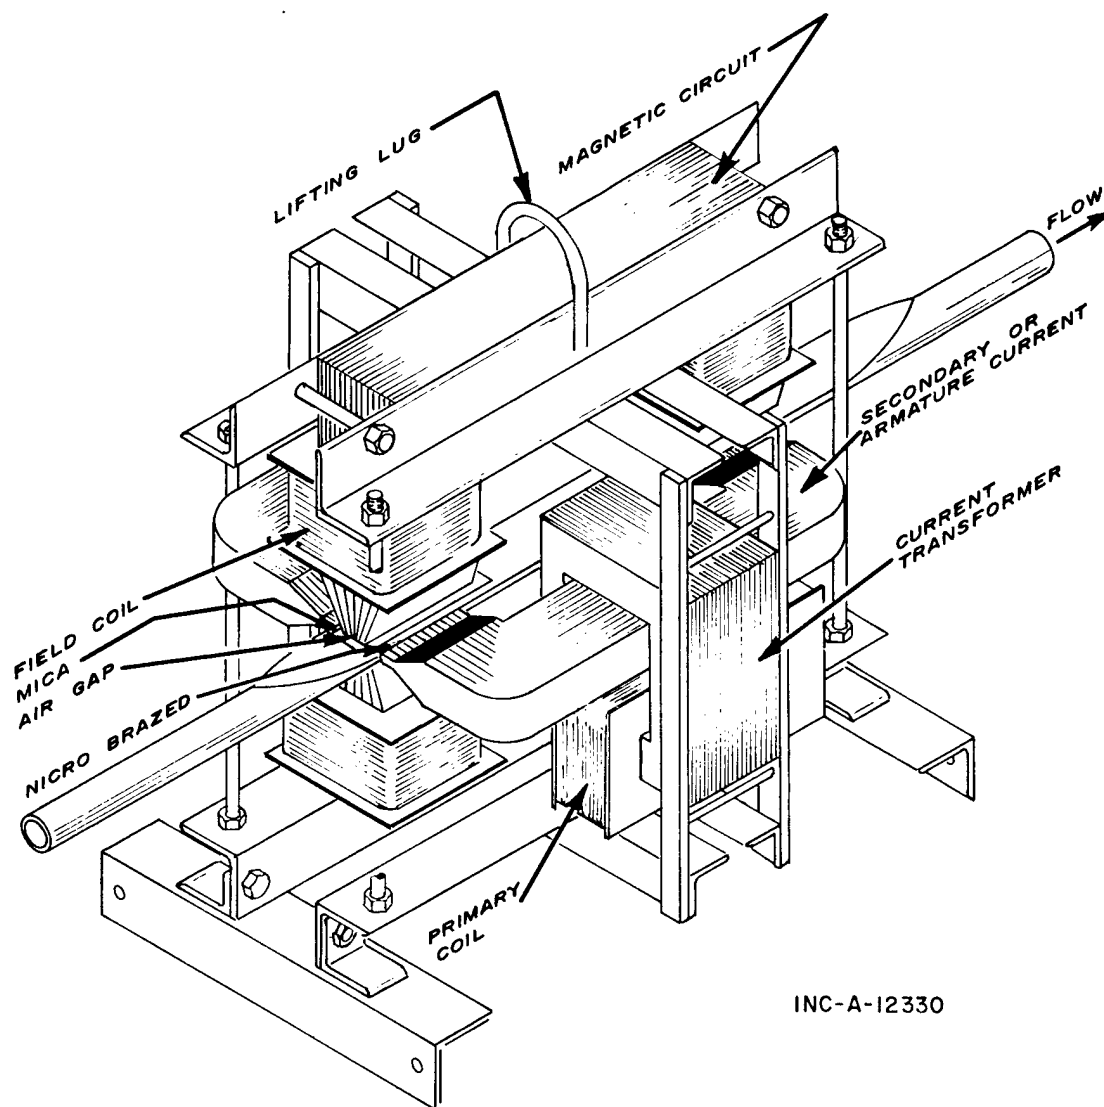
After dismantling the field coil, current transformers, and primary coils, a pin-hole was observed on top of the suction side of the pump tube just under the mica which insulates the field coil from the tube as shown in Figures 32 and 33. Using a 1/4-inch fly-cutter, the tube was machined to expose the NaK side of the pin-hole, Figures 34A, 34B, and 34C.

Figure 32 NaK electromagnetic pump.
